FAA-AM-83-8

CRASHWORTHINESS: AN ILLUSTRATED COMMENTARY ON OCCUPANT  
SURVIVAL IN GENERAL AVIATION ACCIDENTS

APRIL 1983

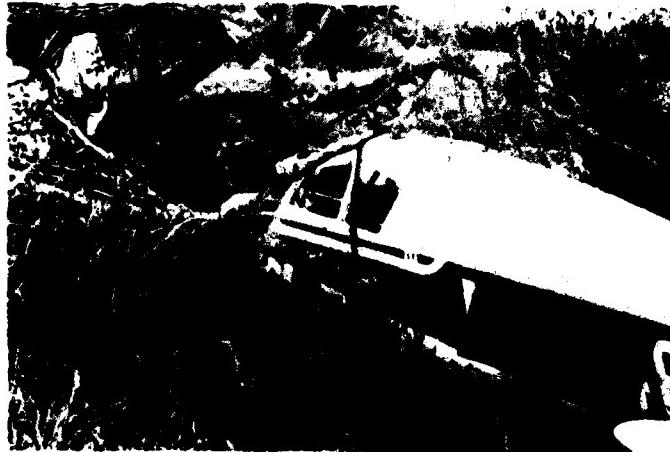
Figure 16

This aircraft (Figure 16) struck relatively level ground and some willow trees. The pilot got out, walked several miles and was then taken to a hospital emergency room. His only injury was a bruised chest.

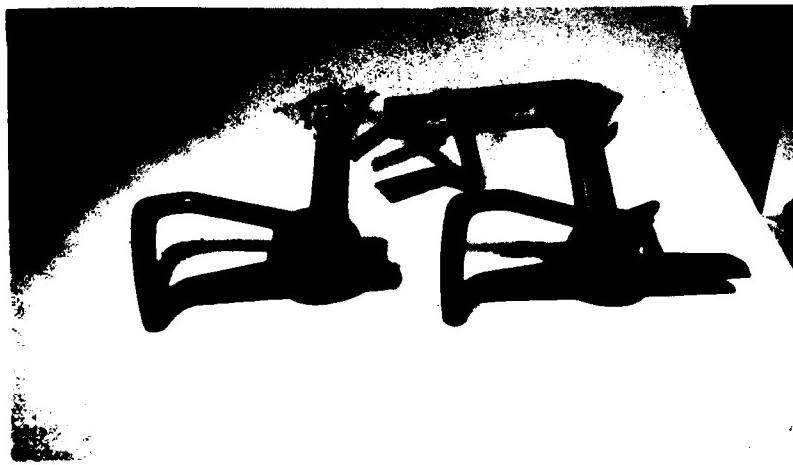
When the control wheels in Figure 18 were examined, two different breaking patterns were noted. The one on the left (pilot's) broke close to the hub as the pilot jackknifed forward and hit the wheel. This resulted in blunt trauma to his chest. The right seat occupant, also jackknifed forward, striking the yoke with his chest and the yoke broke in such a way that a sharp spike remained protruding from the hub. Microscopic examination of a brown film on this spike showed it contained red blood cells, fragments of skin, and pieces of muscle. This "spike" portion of the control wheel

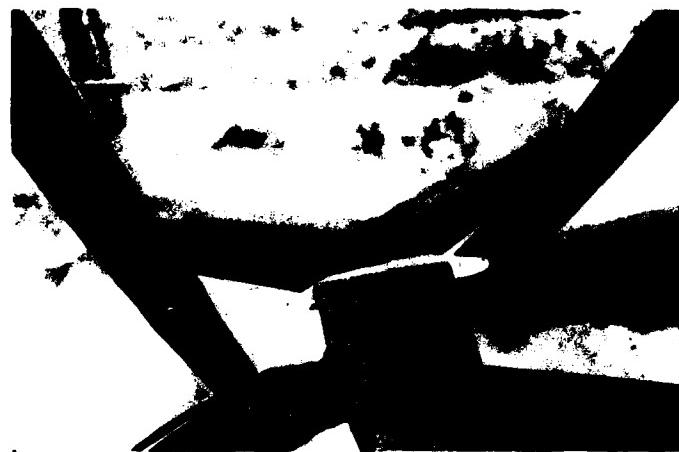
Figure 20

Interestingly, the shoulder harness attachment brace (Figure 20) was found to be bent forward in the shape of a V and the welds were cracked, showing that the force imposed by the pilot against his shoulder harness was of high magnitude. The shoulder harness attachment was bent and apparently near the point of failure, but it remained intact and the pilot was spared serious injury.

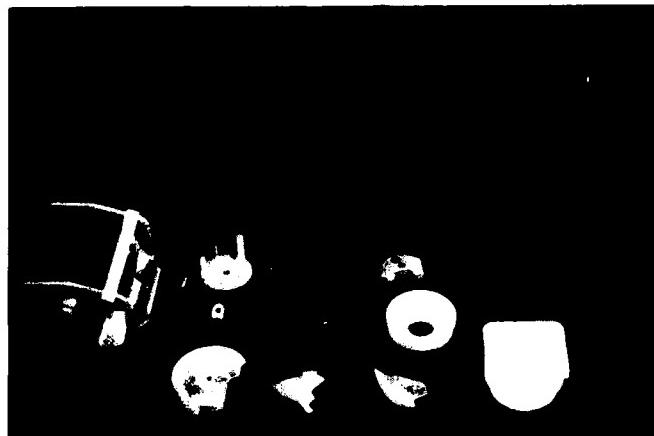
For example, Figure 24 shows an inertia reel that failed in a survivable accident. The pilot was severely injured but survived.

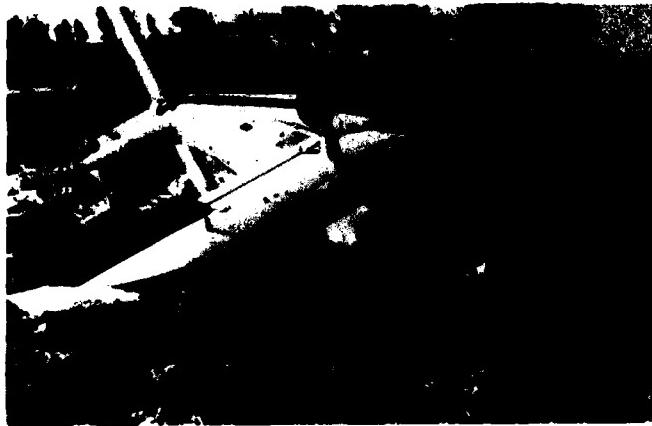
Figure 25

In the accident shown in Figure 25, the impact force was somewhat from the right. The woman in the right front seat was said to have been

using her shoulder harness but she received lethal injuries, probably because of her proximity to the side of the fuselage that struck the ground. The pilot survived but had multiple trauma to the head and chest.

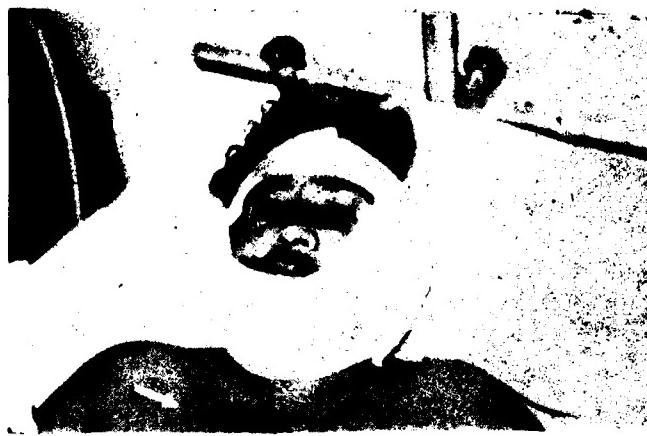
Figure 30

This pilot's injuries illustrate the value of the shoulder harness (Figure 30). The bandage on the head covers a large laceration. Notice marks on his upper chest made when he struck the control wheel. He was wearing the shoulder harness and lapbelt.

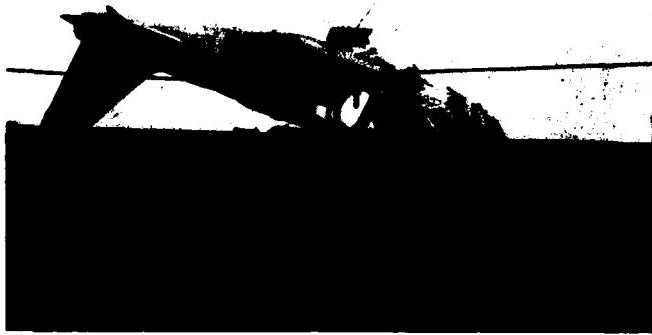
This accident in Figure 33 illustrates the value of the lapbelt in keeping occupants in place. The aircraft with three persons aboard made a downwind takeoff, failed to gain altitude and crashed on top of a building near the airport. The occupant in a rear seat had only a broken finger.

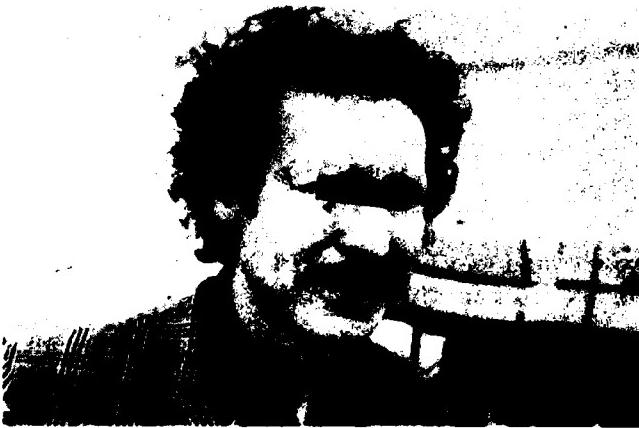
Figure 34

The right seat passenger (shown in Figure 34) had a small cut above his eye. However, the pilot was found on top of the roof, dead from a crushed skull. Why was there this discrepancy in injuries to the occupants? Investigators of accidents in which there are similar disparities in injuries should satisfy themselves as to the sources of these differences.

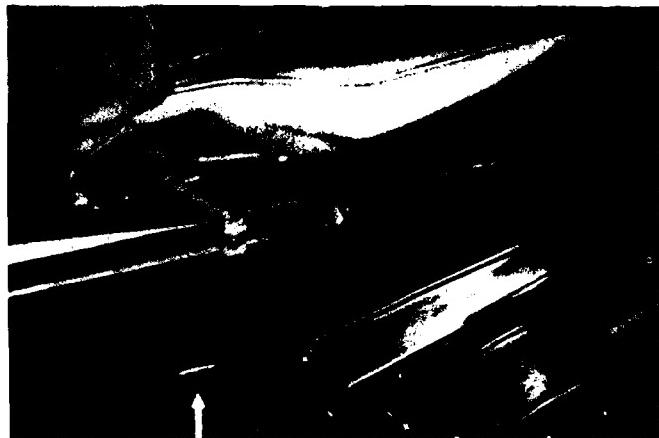
Figure 35

In this accident an investigator would ask "Was the pilot wearing his lap-belt?" Inspection of the floor of the aircraft revealed a slot (as shown in Figure 35) where the right-hand lapbelt attachment had extended through the carpet and was fastened to the underlying metal structures.

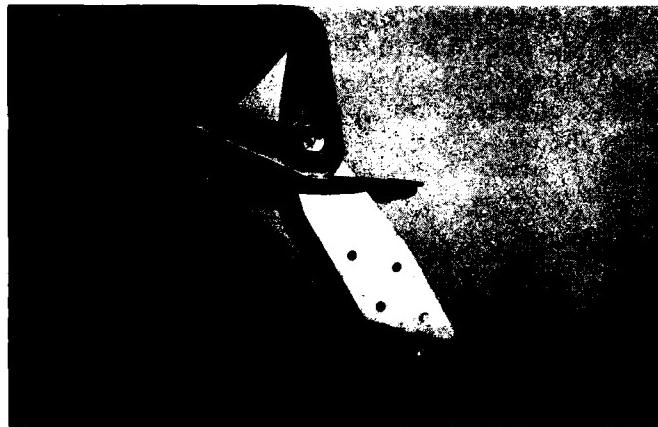
Figure 36

Investigation showed (as in Figure 36) that the lapbelt attachment had pulled free from its anchorage. During impact, sufficient force was applied to the lapbelt (there were no shoulder harnesses) to break its attachment and the pilot was thrown from the aircraft onto the roof of the building. The resulting fatal head injuries were caused by the secondary impact.

Investigators should examine such a lapbelt attachment closely, perhaps even under magnification, to estimate the degree of deformity of each hole to determine whether or not all the rivets or bolts had been in place. Did the restraint fail due to poor manufacture? Was there intrinsic weakness in the materials or attachment configuration?

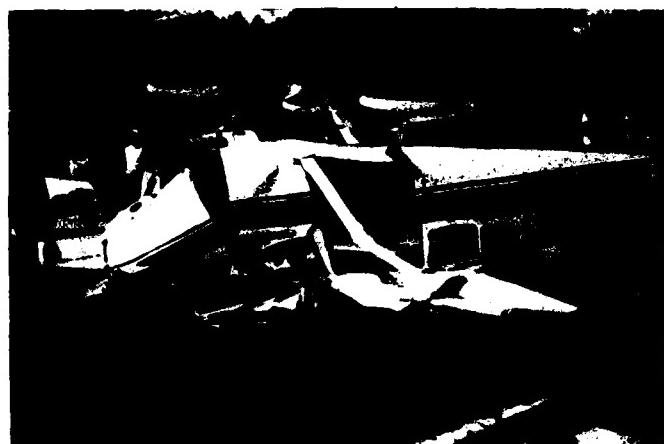
Figure 37

Similar questions should be asked in an accident such as that shown in Figure 37. The aircraft hit electric wires during an attempted emergency landing. Most of the aircraft's forward velocity was dissipated by a large cable; the aircraft then fell upside-down to the ground. Would one expect the pilot to survive this fall? The cabin was intact. Would the lapbelt hold the pilot against the seat and prevent his impact against the inverted top of the aircraft cabin?

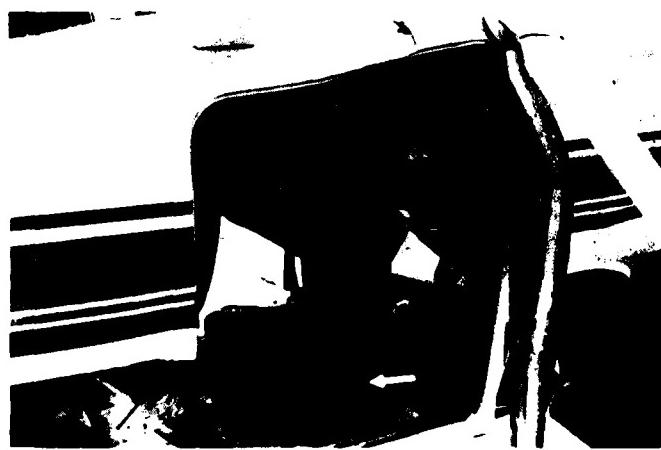
Figure 38

Investigation showed that the lapbelt was hanging with one end free from its attachment as shown in Figure 38.

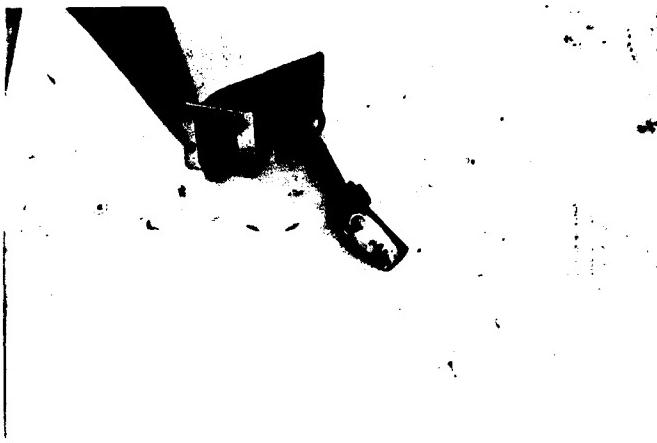
Figure 39

The failed lapbelt attachment is shown in more detail in Figure 39. Note that it was pulled out from its anchorage. The pilot was dead from head and neck injuries. An investigator should ask himself, "Is it reasonable to expect the lapbelt to hold in such an impact?" The engineer should ask himself, "How can the system be strengthened with respect to all the other technical considerations that go into the design and manufacture of an aircraft?" Since this accident, the manufacturer has strengthened the lapbelt attachment in this aircraft model.

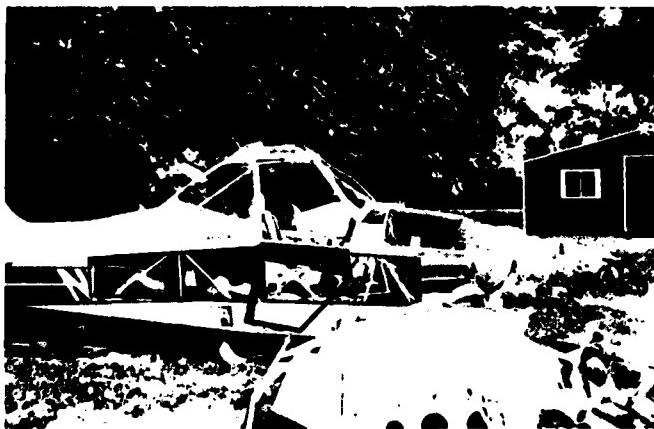
Figure 40

A problem with restraint attachments is illustrated by the accident in Figure 40. The engine was torn off but the cabin structure remained intact.

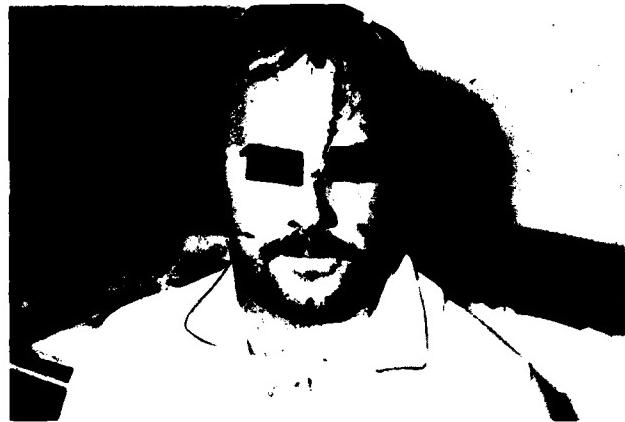
Figure 41

The pilot (Figure 41) sustained a long vertical laceration on his forehead. Accident investigators found a corresponding vertical cleavage in his helmet. By absorbing most of the energy of the head impact, the helmet probably saved this pilot's life. One experienced in crash injury correlation would seek to explain the unusual injury pattern.

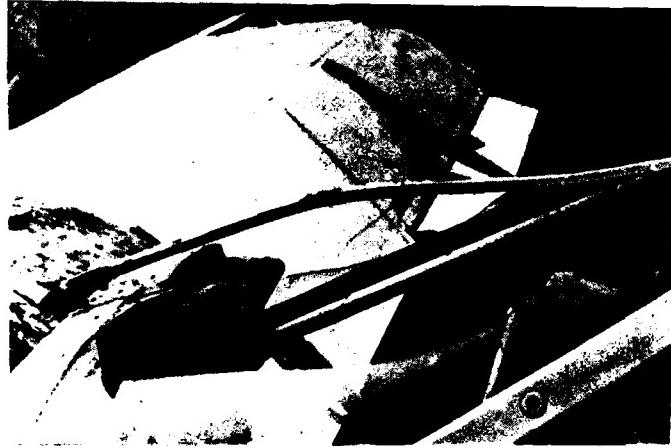
Figure 42

Examination of the aircraft revealed that the windshield was broken and that the vertical wire cutter bar in front of the windshield was bent forward (Figure 42). Here, then, was the most probable explanation for the vertical cleavage in the helmet and corresponding laceration of the pilot's scalp--the pilot had been thrown forward, striking the wire cutter bar with his head. There was also a broad concavity in the instrument panel showing that it had been struck by the pilot's chest. Analysis provided the crash injury correlation but the question remained, "Since the pilot wore a double shoulder harness and lapbelt, why did he travel far enough forward during the crash to strike forward structures in such a 'mild' crash?"

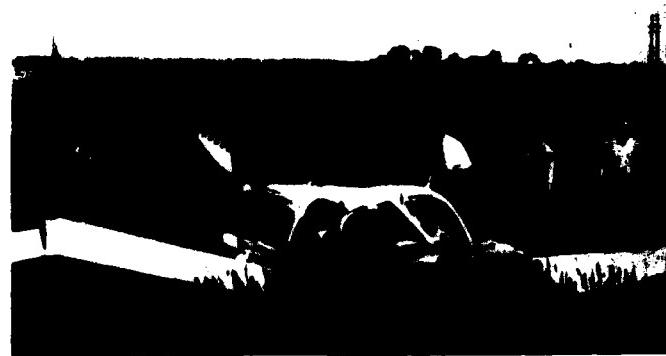
Figure 44

This was an accident (Figure 44) in which there was heavy vertical loading. The aircraft ran out of fuel and hit an overhead power line wire, stalled, and pancaked into a wheat field. The aircraft dropped straight down in a level attitude. None of the six occupants survived. They all sustained severe spinal and internal injuries. Could impact attenuating seats have prevented their deaths?

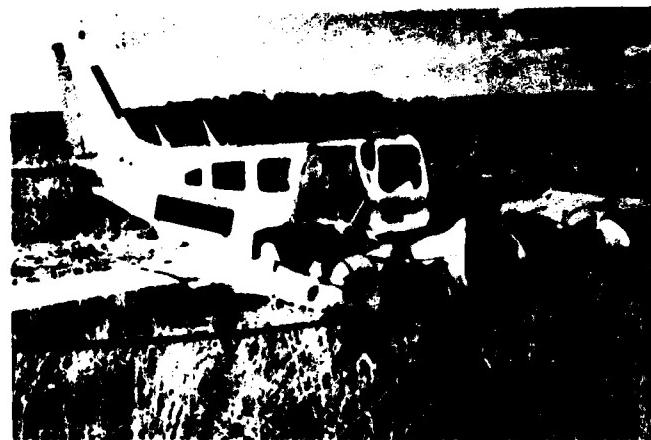
The aircraft in Figure 46 failed to become airborne and during takeoff struck a levee. The deceleration primarily was in a forward direction and one would expect the front seat occupants to receive the most severe injuries. On the contrary, the two occupants in the rear seats sustained fatal injuries and the front seat occupants, who were not using shoulder straps, had severe head injuries but survived.

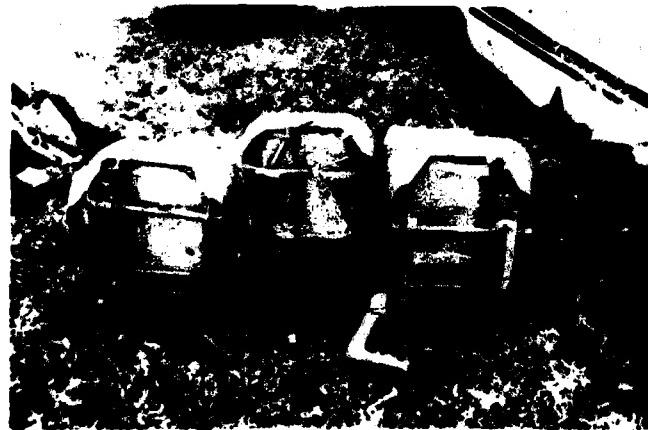
Figure 49

This type of failure occurs suddenly and the occupant is subjected to greater peak loading during secondary impact with the cabin floor or other structures.

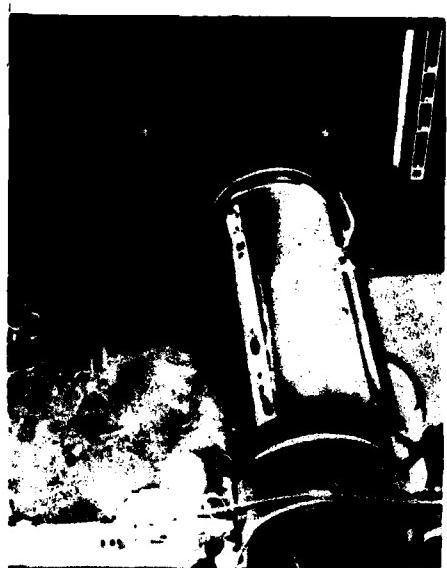
Figure 56

As discussed before, a seat that is rigid may offer little crash energy attenuation of occupant impact. Figure 55 shows an aircraft with an intact fuselage, yet the two occupants had severe spinal injuries--out of proportion to the apparent severity of the accident. What caused the

spinal injuries? A clue is the fact that the wing spar is a large rigid metal tube extending through the cockpit between the floor and the seat bottom.

This spar (with the seat removed) is shown in Figure 56.

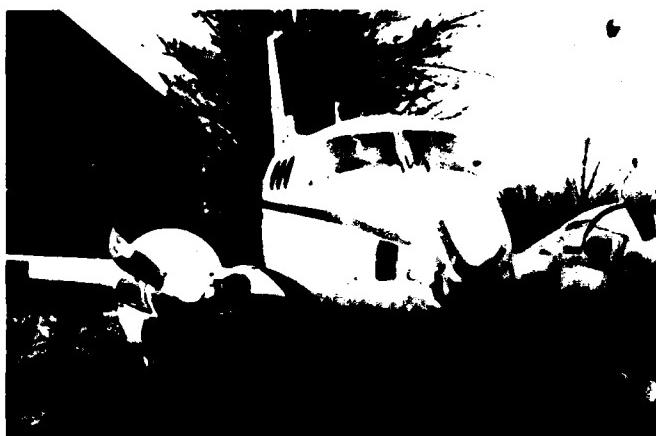
The aircraft shown in Figure 58 landed long and ran off the end of the runway. The structure remained intact and one would expect that the impact was relatively mild, which it was; the pilot was uninjured, three of the four other occupants had only minor injuries.
